Fragility curves for non-engineered masonry buildings in developing countries derived from real data based on structural surveys and laboratory tests

Viviana Iris Novelli^{1,2} · Raffaele De Risi² · Ignasio Ngoma³ · Innocent Kafodya³ · Panos Kloukinas⁴ · John Macdonald² · Katsuichiro Goda⁵

Abstract

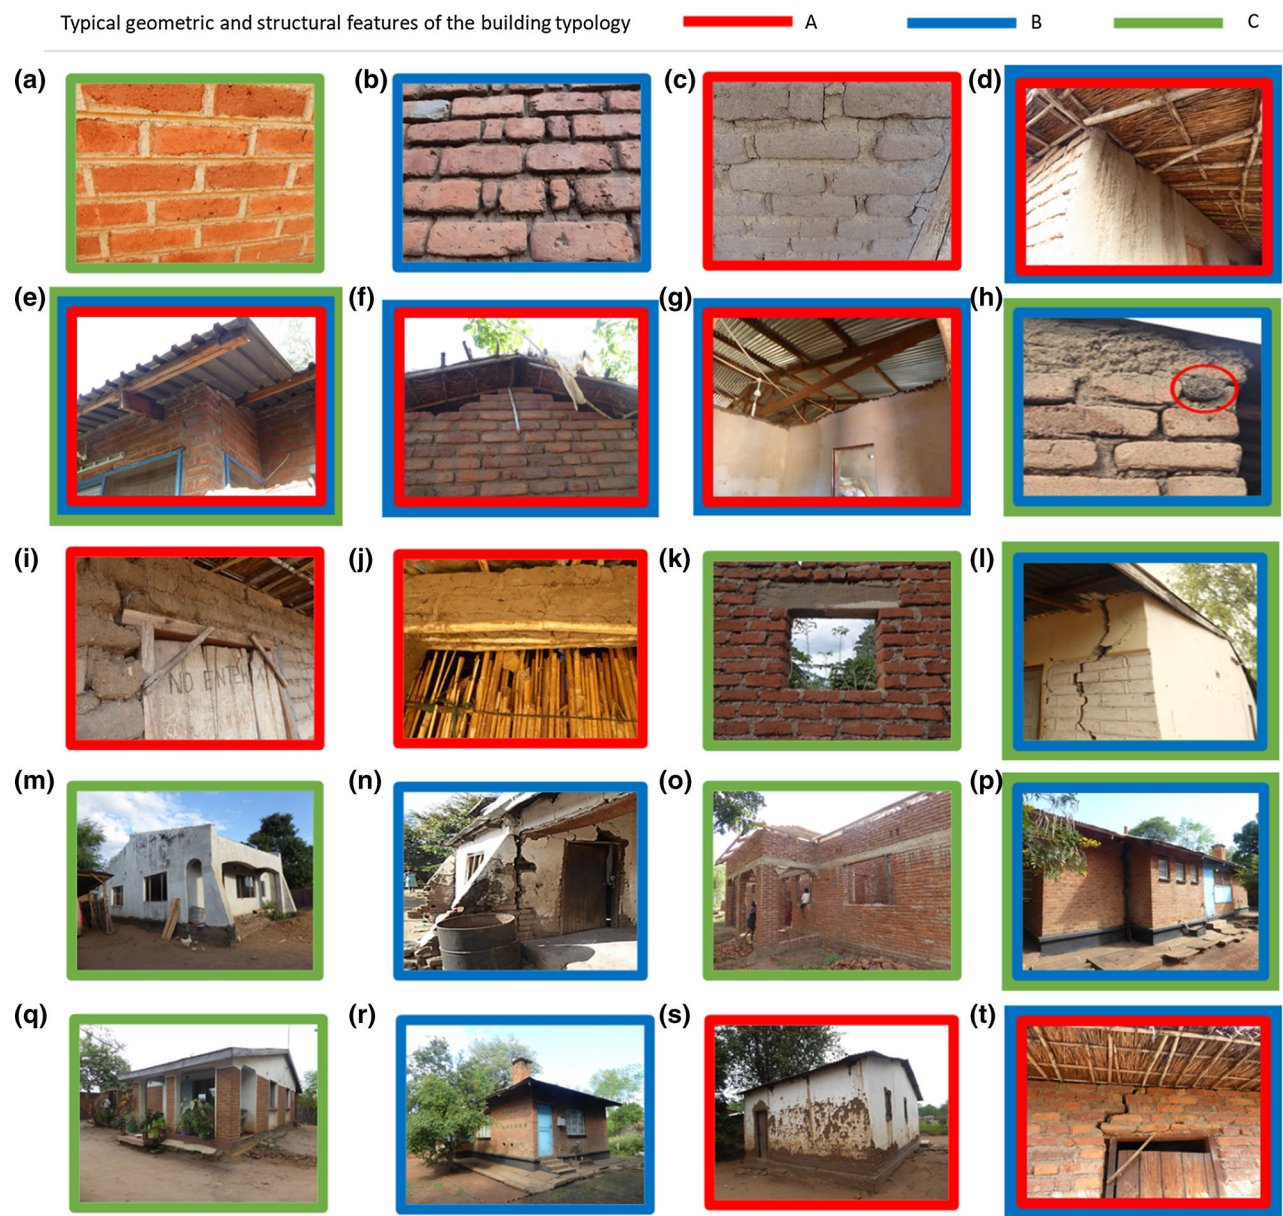
Fig. 6 Typical buildings in Malawi: **a** fired bricks with cement mortar; **b** fired bricks with mud mortar; **c** unfired bricks with mud mortar; **d** thatched roof; **e** light metallic sheets; **f** gable detached from the roof structure; **g** lack of connection between walls and roof system; **h** timber wall plates of circular section; **i** door frame showing absence of lintels; **j** bamboo lintel; **k** concrete lintel; **l** house with poor

connection between walls; **m** new constructions with buttresses; **n** lack of connection between buttress and wall; **o** concrete ring beam; **p** re-entrant corner; **q** portico; **r** chimney; **s** material erosion; **t** typical cracks. The red-blue-green tag on each picture is used to highlight the geometric/structural features of the building typologies A, B, and C, introduced in Sect. 3.1.1

On-site structural surveys were carried out on 323 non-engineered unreinforced masonry buildings located in formal and informal settlements in the townships of Salima and Balaka and informal settlements of the villages Lifidzi and Golomoti (see Fig. 1b). 86% of the inspected buildings are made of fired (clay) bricks (see Fig. 6a, b), since these materials are relatively cheap to source on-site and do not need specific construction skills. The remaining 14% of the inspected buildings are made of mud bricks (see Fig. 6c), a

corrugated sheets are observed for the remaining inspected buildings (Fig. 6e). Both roof types do not act as a rigid diaphragm during an earthquake. Furthermore, roofs generally are not connected to the bearing walls; therefore, they are not able to provide restraint against lateral movements due to winds or earthquakes (Fig. 6f, g). Only occasionally, timber wall plates are used on the top of the longest external walls to support the roof structures

the roof and openings. This is evident from the presence of cracks, material erosion, dry timber rot, damaged boards, and door jams (Fig. 6s, t).

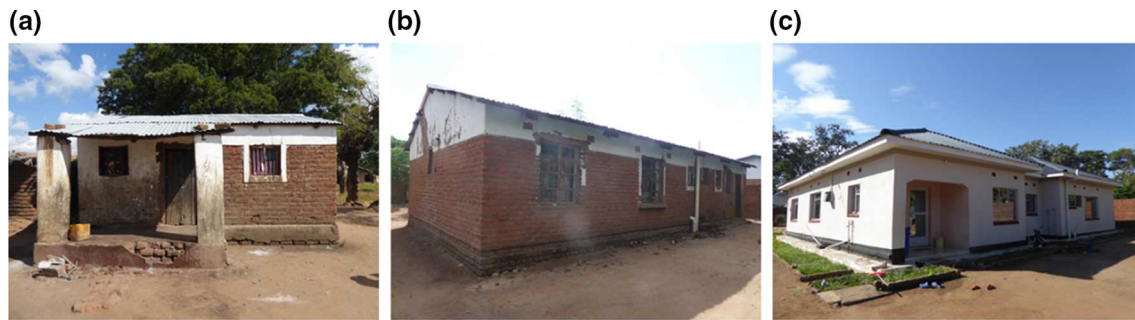
Fig. 8 Typical masonry buildings in Malawi: **a** typology A; **b** typology B; **c** typology C

- **Typology B**—This is the most common typology observed in Malawi, representing 50% of the buildings, and is rated as medium seismic vulnerability (Fig. 8b). These buildings are made of fired bricks with medium- to good-quality fabric (Fig. 3b1, b2). Due to the presence of mud mortar, bonding between bricks is considered poor; therefore, connections between walls are assumed weak. The construction details varied significantly as well as maintenance levels.
